# CORNER RESTORATION

E  $\frac{1}{4}$  corner  
CORNER Sec. 24 TWP 18 S RANGE 28E

ORIGINAL SURVEY BY: Bamford Robb

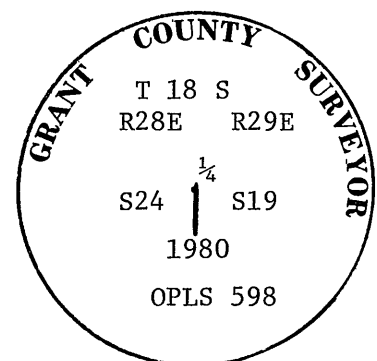
## MONUMENT MARKED

At the corner point: Set a  $1\frac{1}{2}$ "x30" galvanized iron pipe 26 inches in the ground with brass cap marked as shown.
