CORNER RESTORATION

CORNER: S $\frac{1}{4}$ Sec:21 TWP: 13S. RANGE:30E.

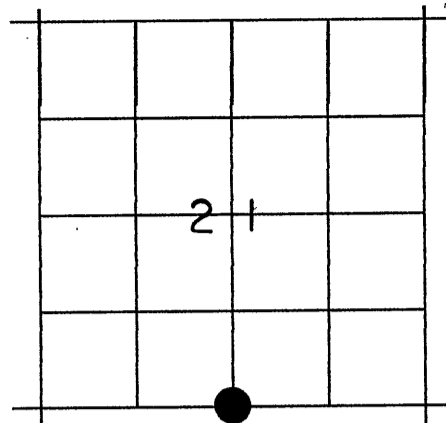
EVIDENCE FOUND: The original cor. stone has long since been destroyed. The 1968 brass cap and RP's have also been destroyed during highway resurfacing. Through the years during private surveys in the area I had tied and referenced the position of the brass cap set in 1968. Upon it's disappearance several years ago, I set a narrow gage railroad spike at the same position of the brass cap. I used my reference notes and control to reset this corner. Upon chipping a hole 4" deep in the pavement we recovered a 40d nail and the railroad spike at the corner point.

<p>At the corner point: I set a 5/8"x24" copper clad iron rod 26" in the paved hwy. surface with attached Grant County Surveyor brass cap marked as shown. From which I SET THE FOLLOWING REFERENCE POINTS: A $\frac{1}{2}$"x$1\frac{1}{2}$" PK nail, set flush in construction seam in top of concrete sidewalk at NW cor. of Beech Creek bridge, bears N.81°27'E., 131.34 ft. A $\frac{1}{2}$"x$1\frac{1}{2}$" PK nail, set flush in construction seam in top of concrete sidewalk at SW cor. of Beech Creek bridge bears S.80°54'E., 120.89 ft. The NE cor. of the brick siding Post Office Building bears S.29°29"W., 46.60 ft. A $\frac{1}{2}$"x$1\frac{1}{2}$" PK nail, set flush in construction seam of concrete sidewalk, bears N.76°51'W., 119.05 ft. Bearings to RP's are based on solar observation. We set monument 2" below paved street surface of US Highway 26, at Ingle Street, and poured concrete around monument to top of brass cap.</p>	<p>MONUMENT MARKED GRANT COUNTY SURVEYOR T13SR30E S21 $\frac{1}{4}$ ——— S28 1993 OPLS 598</p>
