# CORNER RESTORATION

E  $\frac{1}{4}$  corner  
CORNER Sec. 24 TWP 18 S RANGE 28E

ORIGINAL SURVEY BY: Bamford Robb

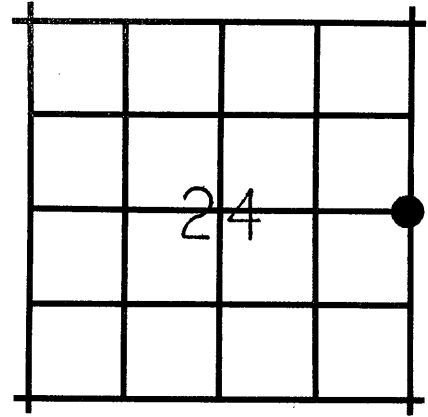
At the corner point: Found remains of original corner post (rotten) after shaving away 4 inches of top soil. A dim mound of stone was scattered around post.

At the corner point: Set a  $1\frac{1}{2}$ "x30" galvanized iron pipe 26 inches in the ground with brass cap marked as shown.

A 5" Juniper bears S.  $88^{\circ}$  W., 185.5 ft. mkd.  $\frac{1}{4}$  S24 CSBT  
An 8" Juniper bears S.  $49^{\circ}$  E., 178.2 ft. mkd.  $\frac{1}{4}$  S19 CSBT

Buried remains of post in hole alongside iron pipe as a memorial.
