MAP OF SURVEY  
DEPENDENT RESURVEY SITUATED IN  
SECTIONS 17 AND 20  
T16S, R28E, W.M.

GRANT COUNTY, OREGON

SURVEYED FOR: **Loren Stout and Malheur National Forest**

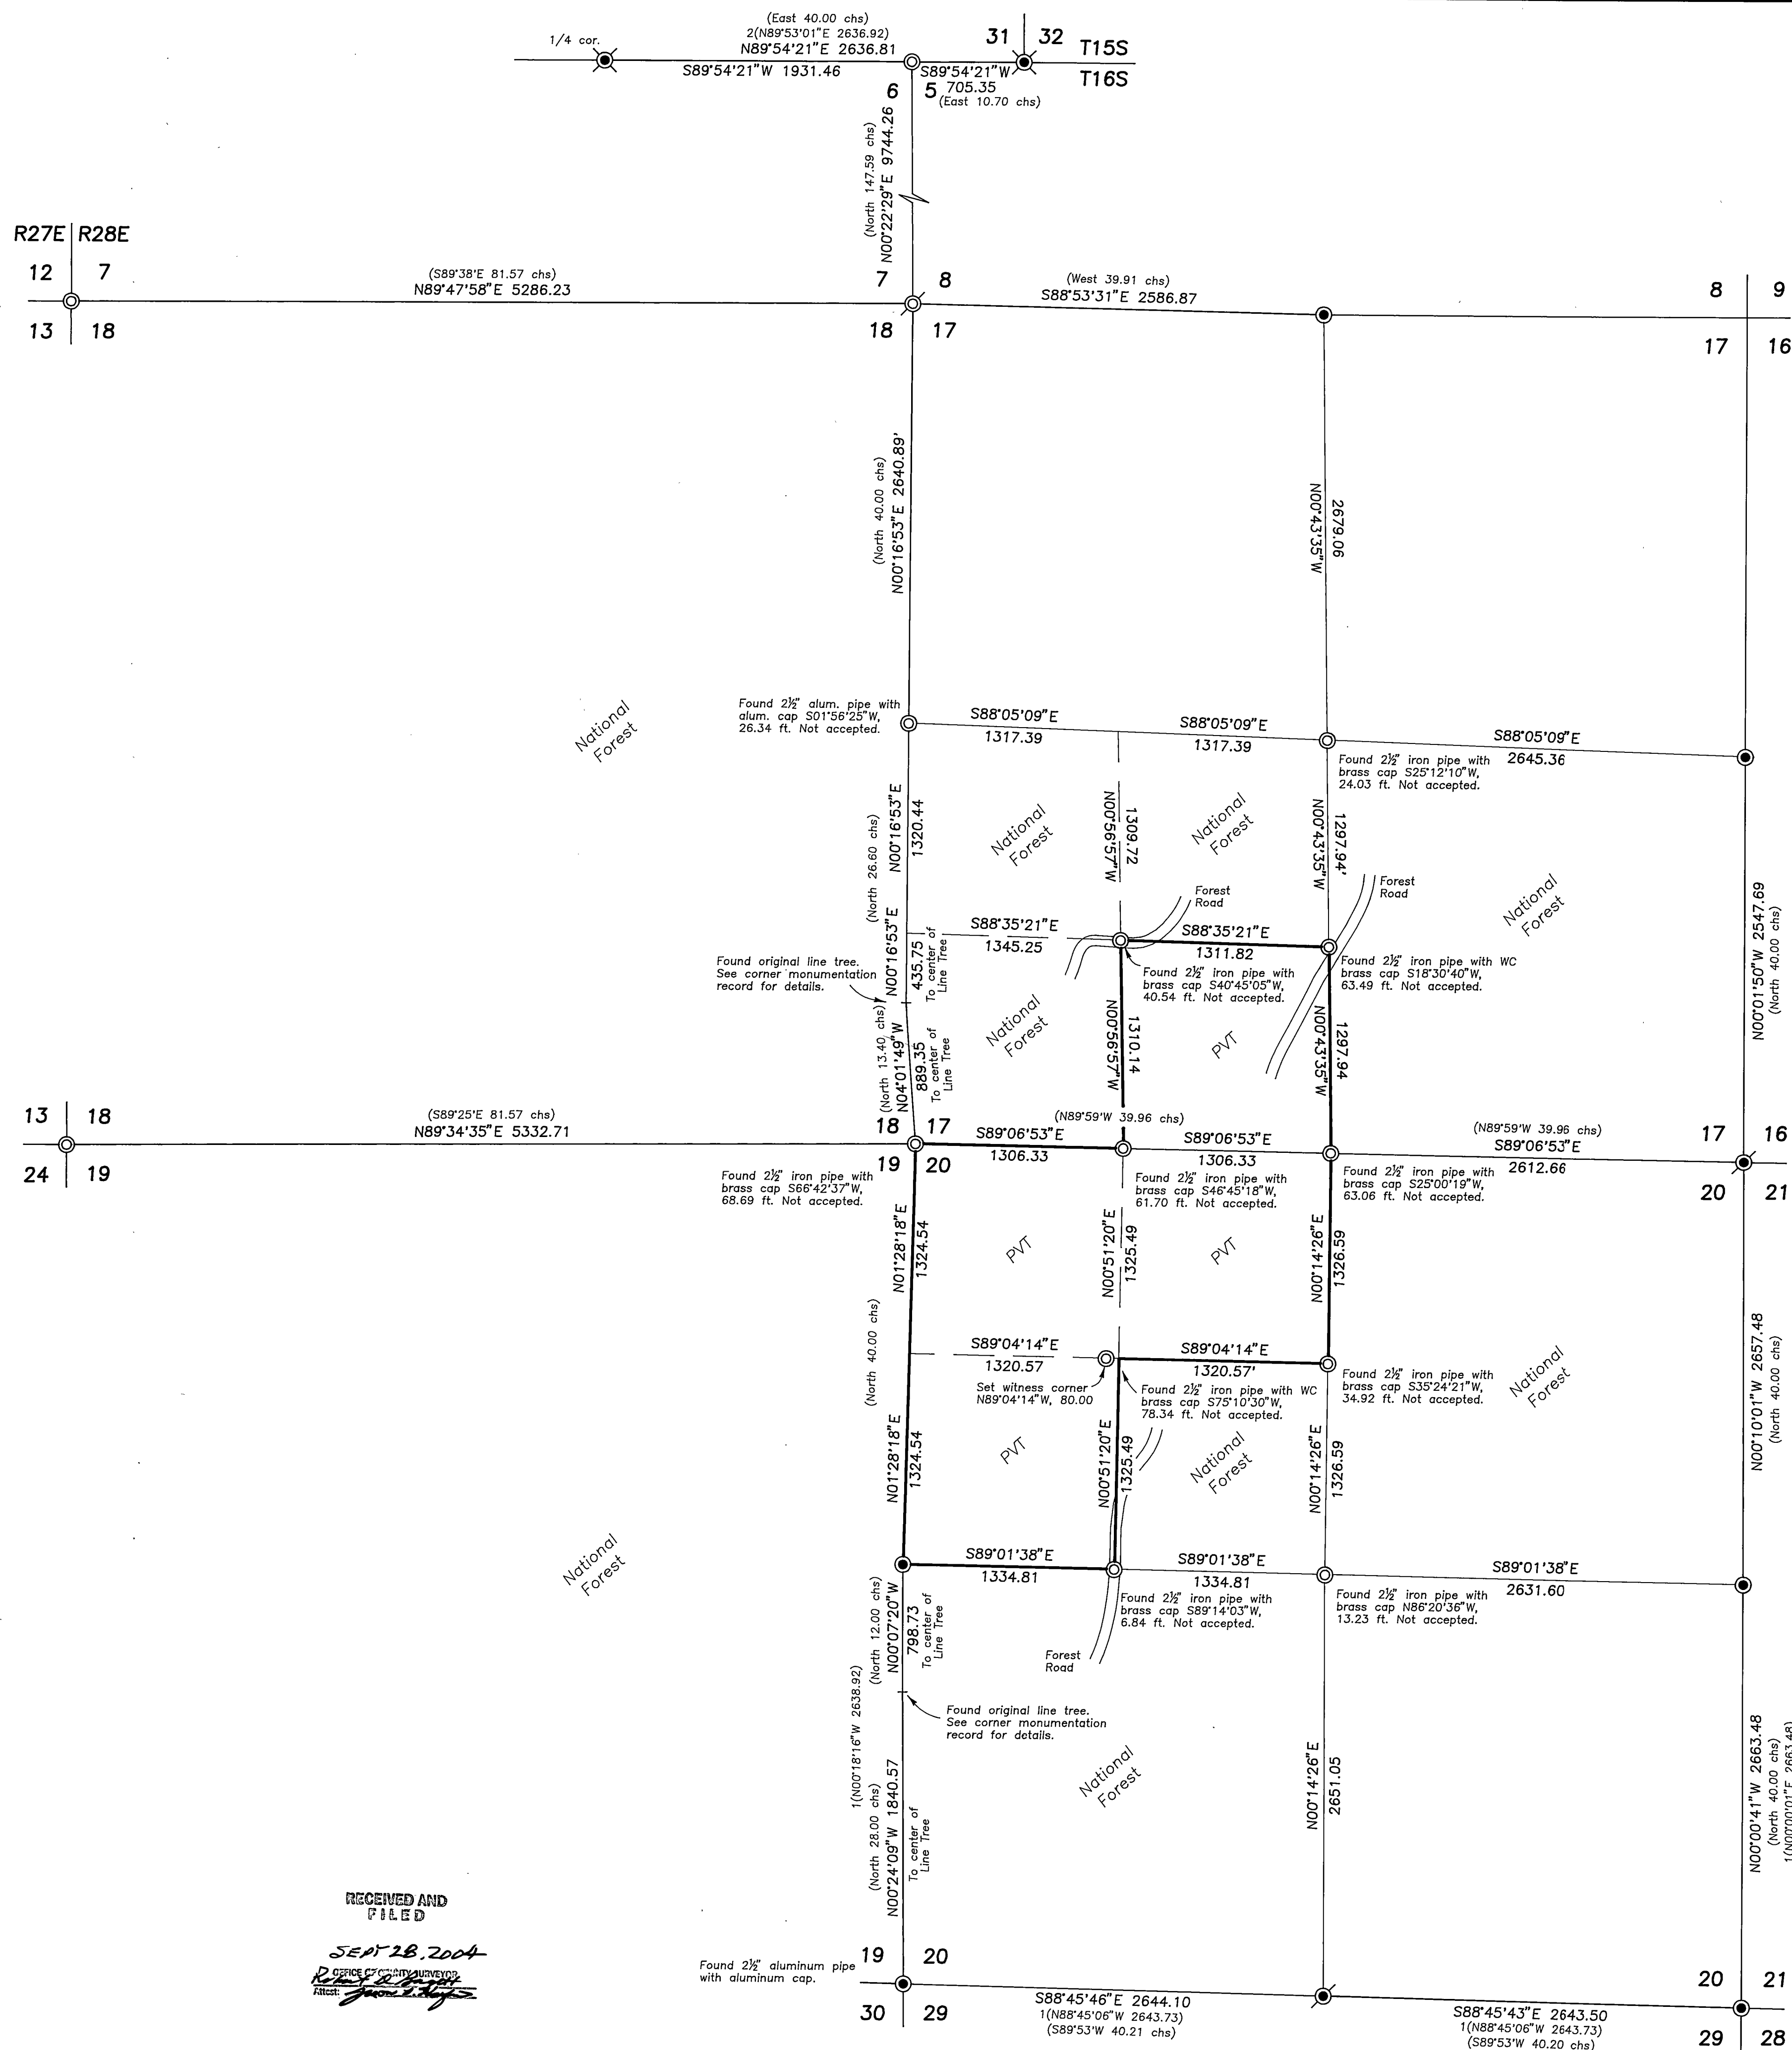
This survey was performed at the request of Loren Stout and Roger W. Williams, Forest Supervisor, Malheur National Forest. The purpose of this survey was to evaluate the corner evidence used to position the lines of the SE1/4SW1/4 of Section 17 and the NE1/4NW1/4 and the W1/2NW1/4 of Section 20, T16S, R28E, W.M. as shown on Survey No. 587. Several of the controlling corners for Survey No. 587 were determined to not represent the original corner positions. A ring count was done on the bearing tree at the NW corner of Section 20 and proved to be only 60 years from the time it was scribed. This made the corner position suspect. An examination of the evidence used to position the N1/4 corner of Section 20 proved to be inconclusive as did the evidence at the W1/4 corner of Section 17. The evidence found at the W1/4 of Section 20 is now gone and could not be verified. Therefore the scope of this survey changed to include the dependant resurvey of Sections 17 and 20 and the subdivision of these two sections to establish property lines of the above described tract that relies on the corner evidence accepted in this survey.

This survey was performed using static GPS receivers and an electronic total station. The bearings for this survey are based on the GPS survey. The GPS survey was made in NAD 83 State Plane Coordinates, Oregon North Zone. The state plane bearings were rotated clockwise 00°47'07\"/>
