This survey was performed at the request of Philip Merricks. The purpose of this survey was to establish the property corners of Parcel 2, Land Partition No. 99-03.

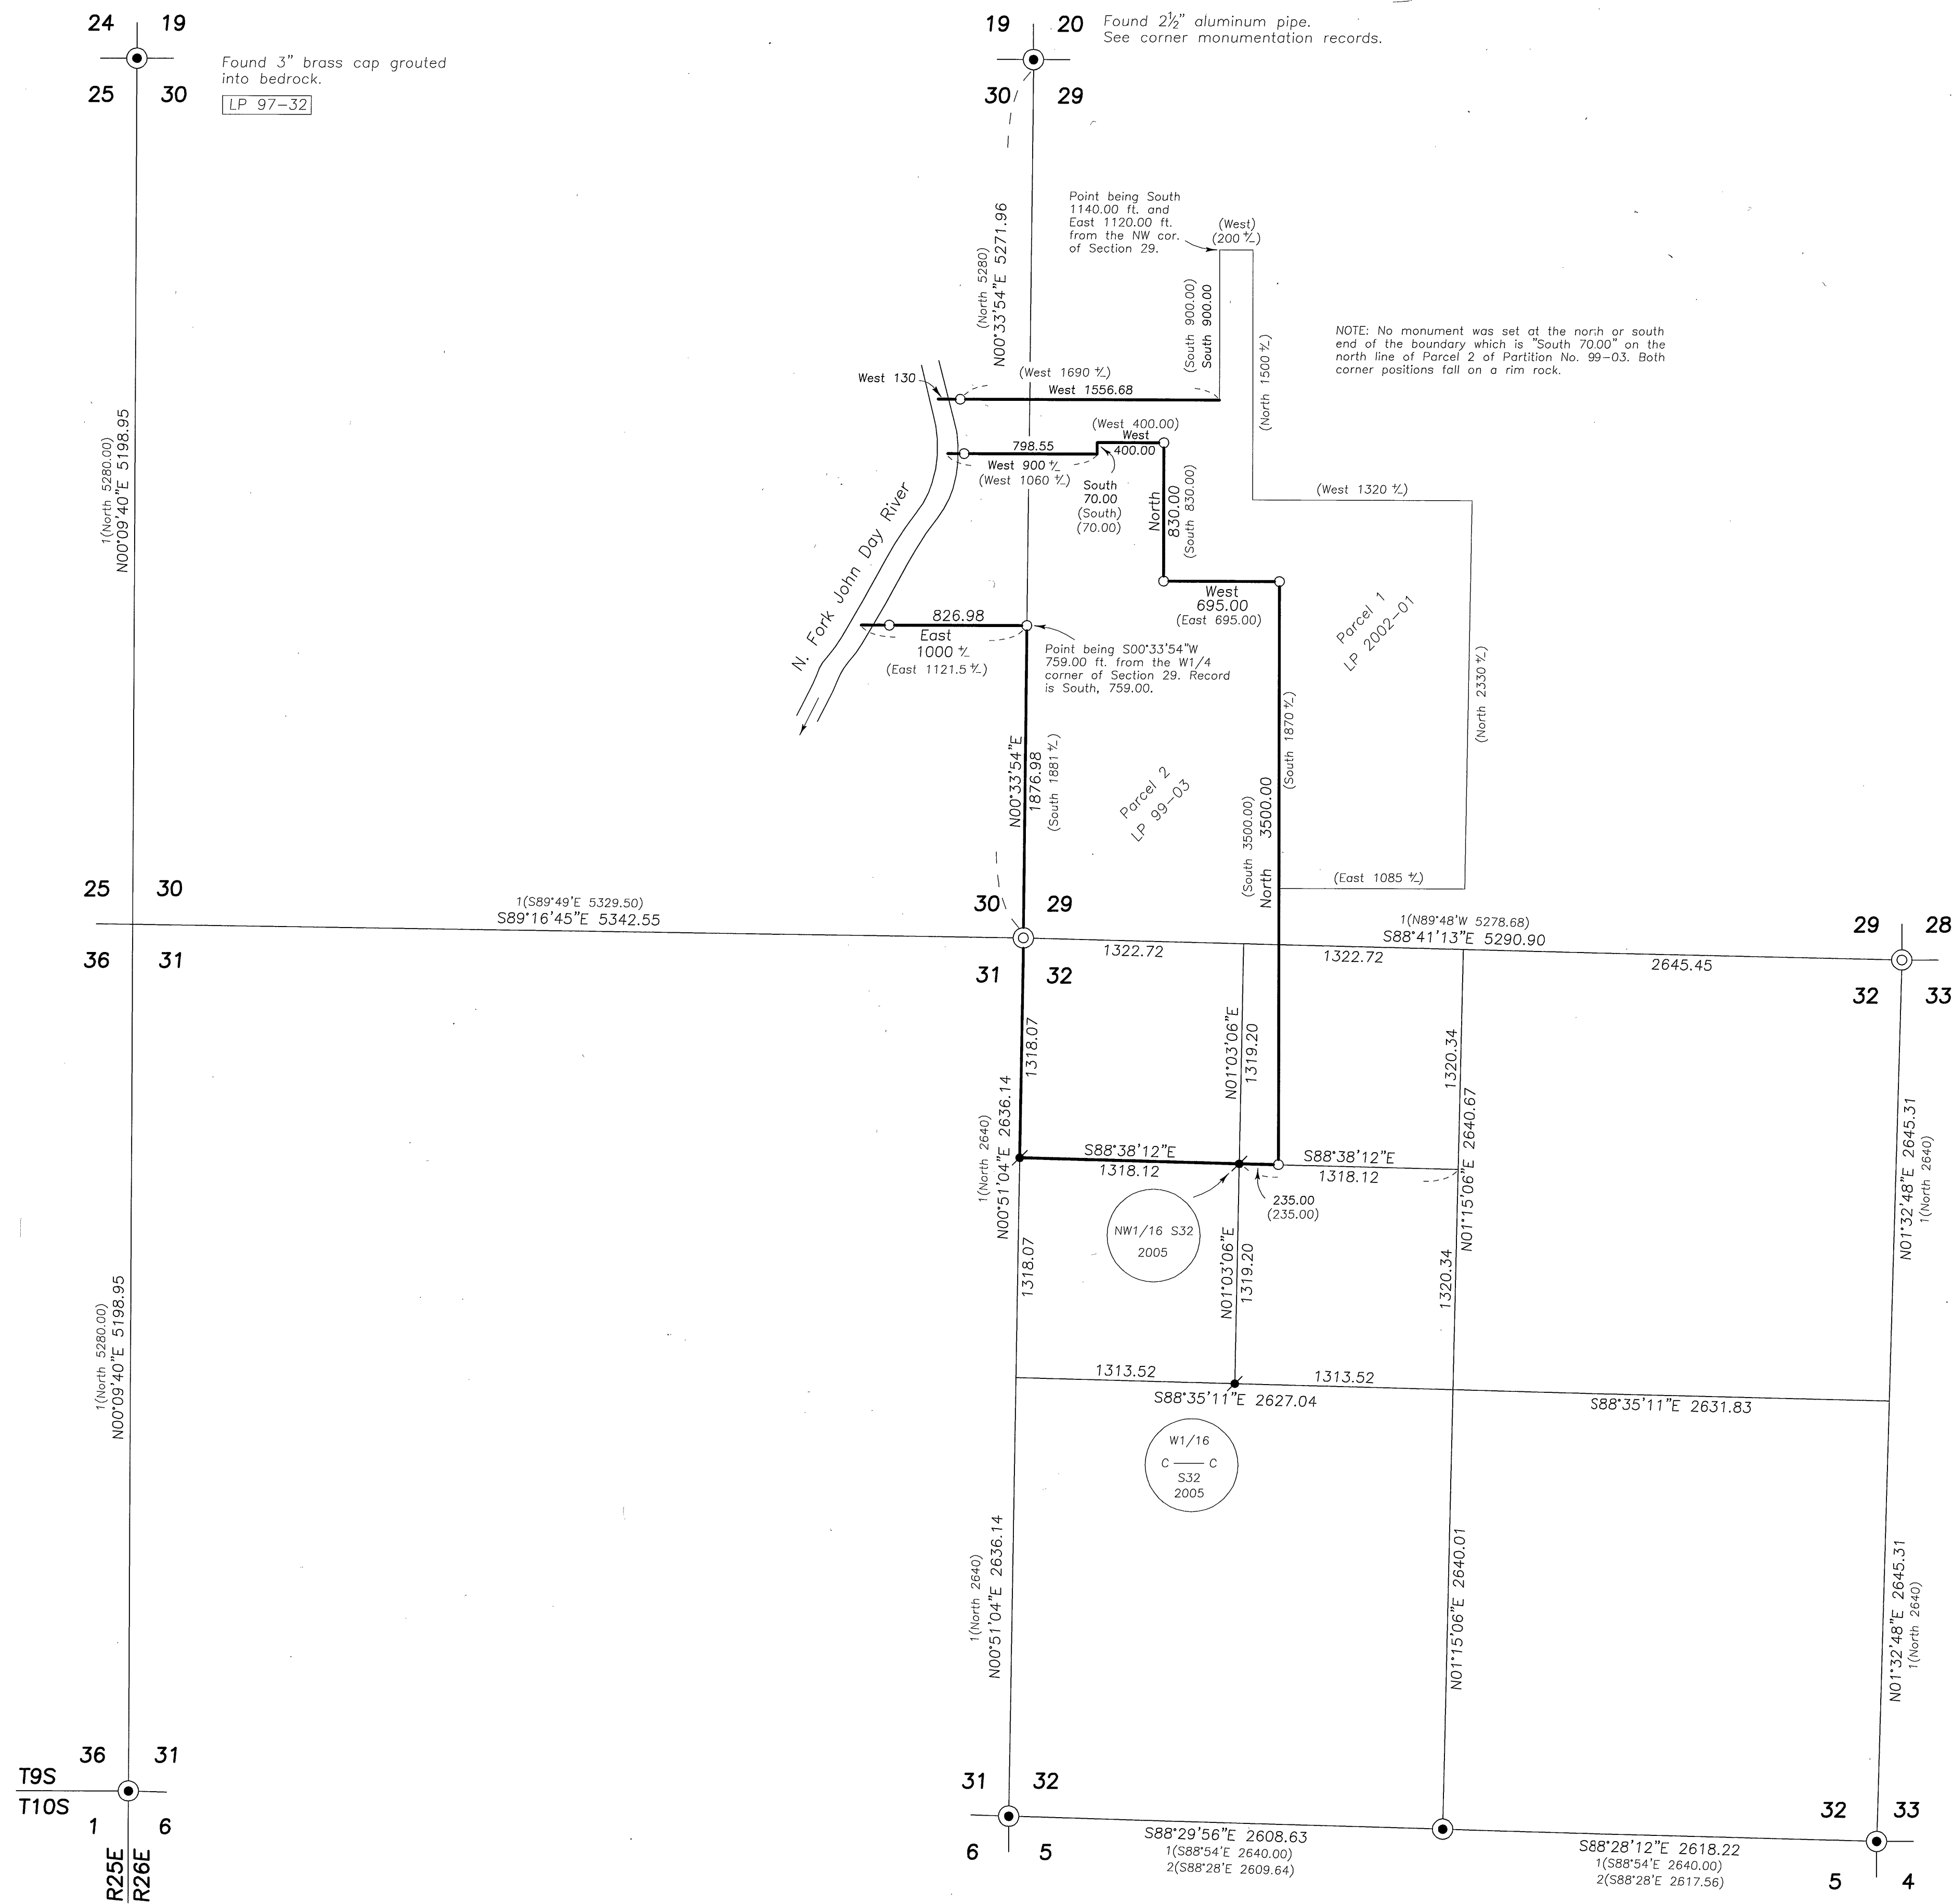
Scale 1"=600'

This survey was performed using static GPS receivers and Electronic Total Station. The bearings for this survey are based on the GPS survey. The GPS survey was made in NAD 83 State Plane Coordinates, Oregon North Zone. The State Plane bearings were rotated clockwise 00°36'44" to true north at the NW corner of Section 29, T9S, R26E. All Bearings are relative to this local north meridian.

A search was made of the available records pertaining to this survey. A subdivision of Section 32 was required to establish the position of the NW1/4 corner. I searched for the controlling corners of Section 32 and found the original corner stone at the NE corner of Section 32, which I re-monumented. The BLM performed a re-survey of T10S, R26E in 1961, under special instructions, dated August 17, 1955, see Grant County Survey No. 132. I found and accepted the BLM monuments on the south boundary of Section 32 and at the SW corner of Section 31. I accepted the found monuments at the NE and NW corner of Section 30, which were monumented in previous surveys as shown. The original corner monument at the W1/4 corner of Section 29 was found out of position. The landowner explained that the boulder was bulldozed out of the orchard after the 1964 flood.

No corner evidence was found at the E1/4, N1/4, W1/4 or the NW corner of Section 32. No corner evidence was found at the W1/4, N1/4 or the NW corner of Section 31 or at the W1/4 of Section 30. These corner positions were determined by proportionate measurement in accordance with the 1973 BLM manual of surveying instructions. Section 32 was subdivided in the usual manner and the corner positions of Parcel 2 of Partition No. 99-03 were established using the deed record as shown on said partition plat, which is recorded in the office of the Grant County Clerk. The NW corner of Parcel 1 of Land Partition No. 2002-01 was also established using the deed record shown on that partition plat, which is recorded in the office of the Grant County Clerk.
