MAP OF SURVEY
 DEPENDENT RESURVEY AND SUBDIVISION OF SECTION 17
 T.14S., R.31E., W.M.
 GRANT COUNTY, OREGON

SURVEYED FOR	S&M LAND DEVELOPMENT, LLC.	
SURVEYED BY	JLH & MCS	5/23/2012
SCALE: 1"=1000'	DRAWN BY: JLH

NARRATIVE FOR MAP OF SURVEY NO. 1949

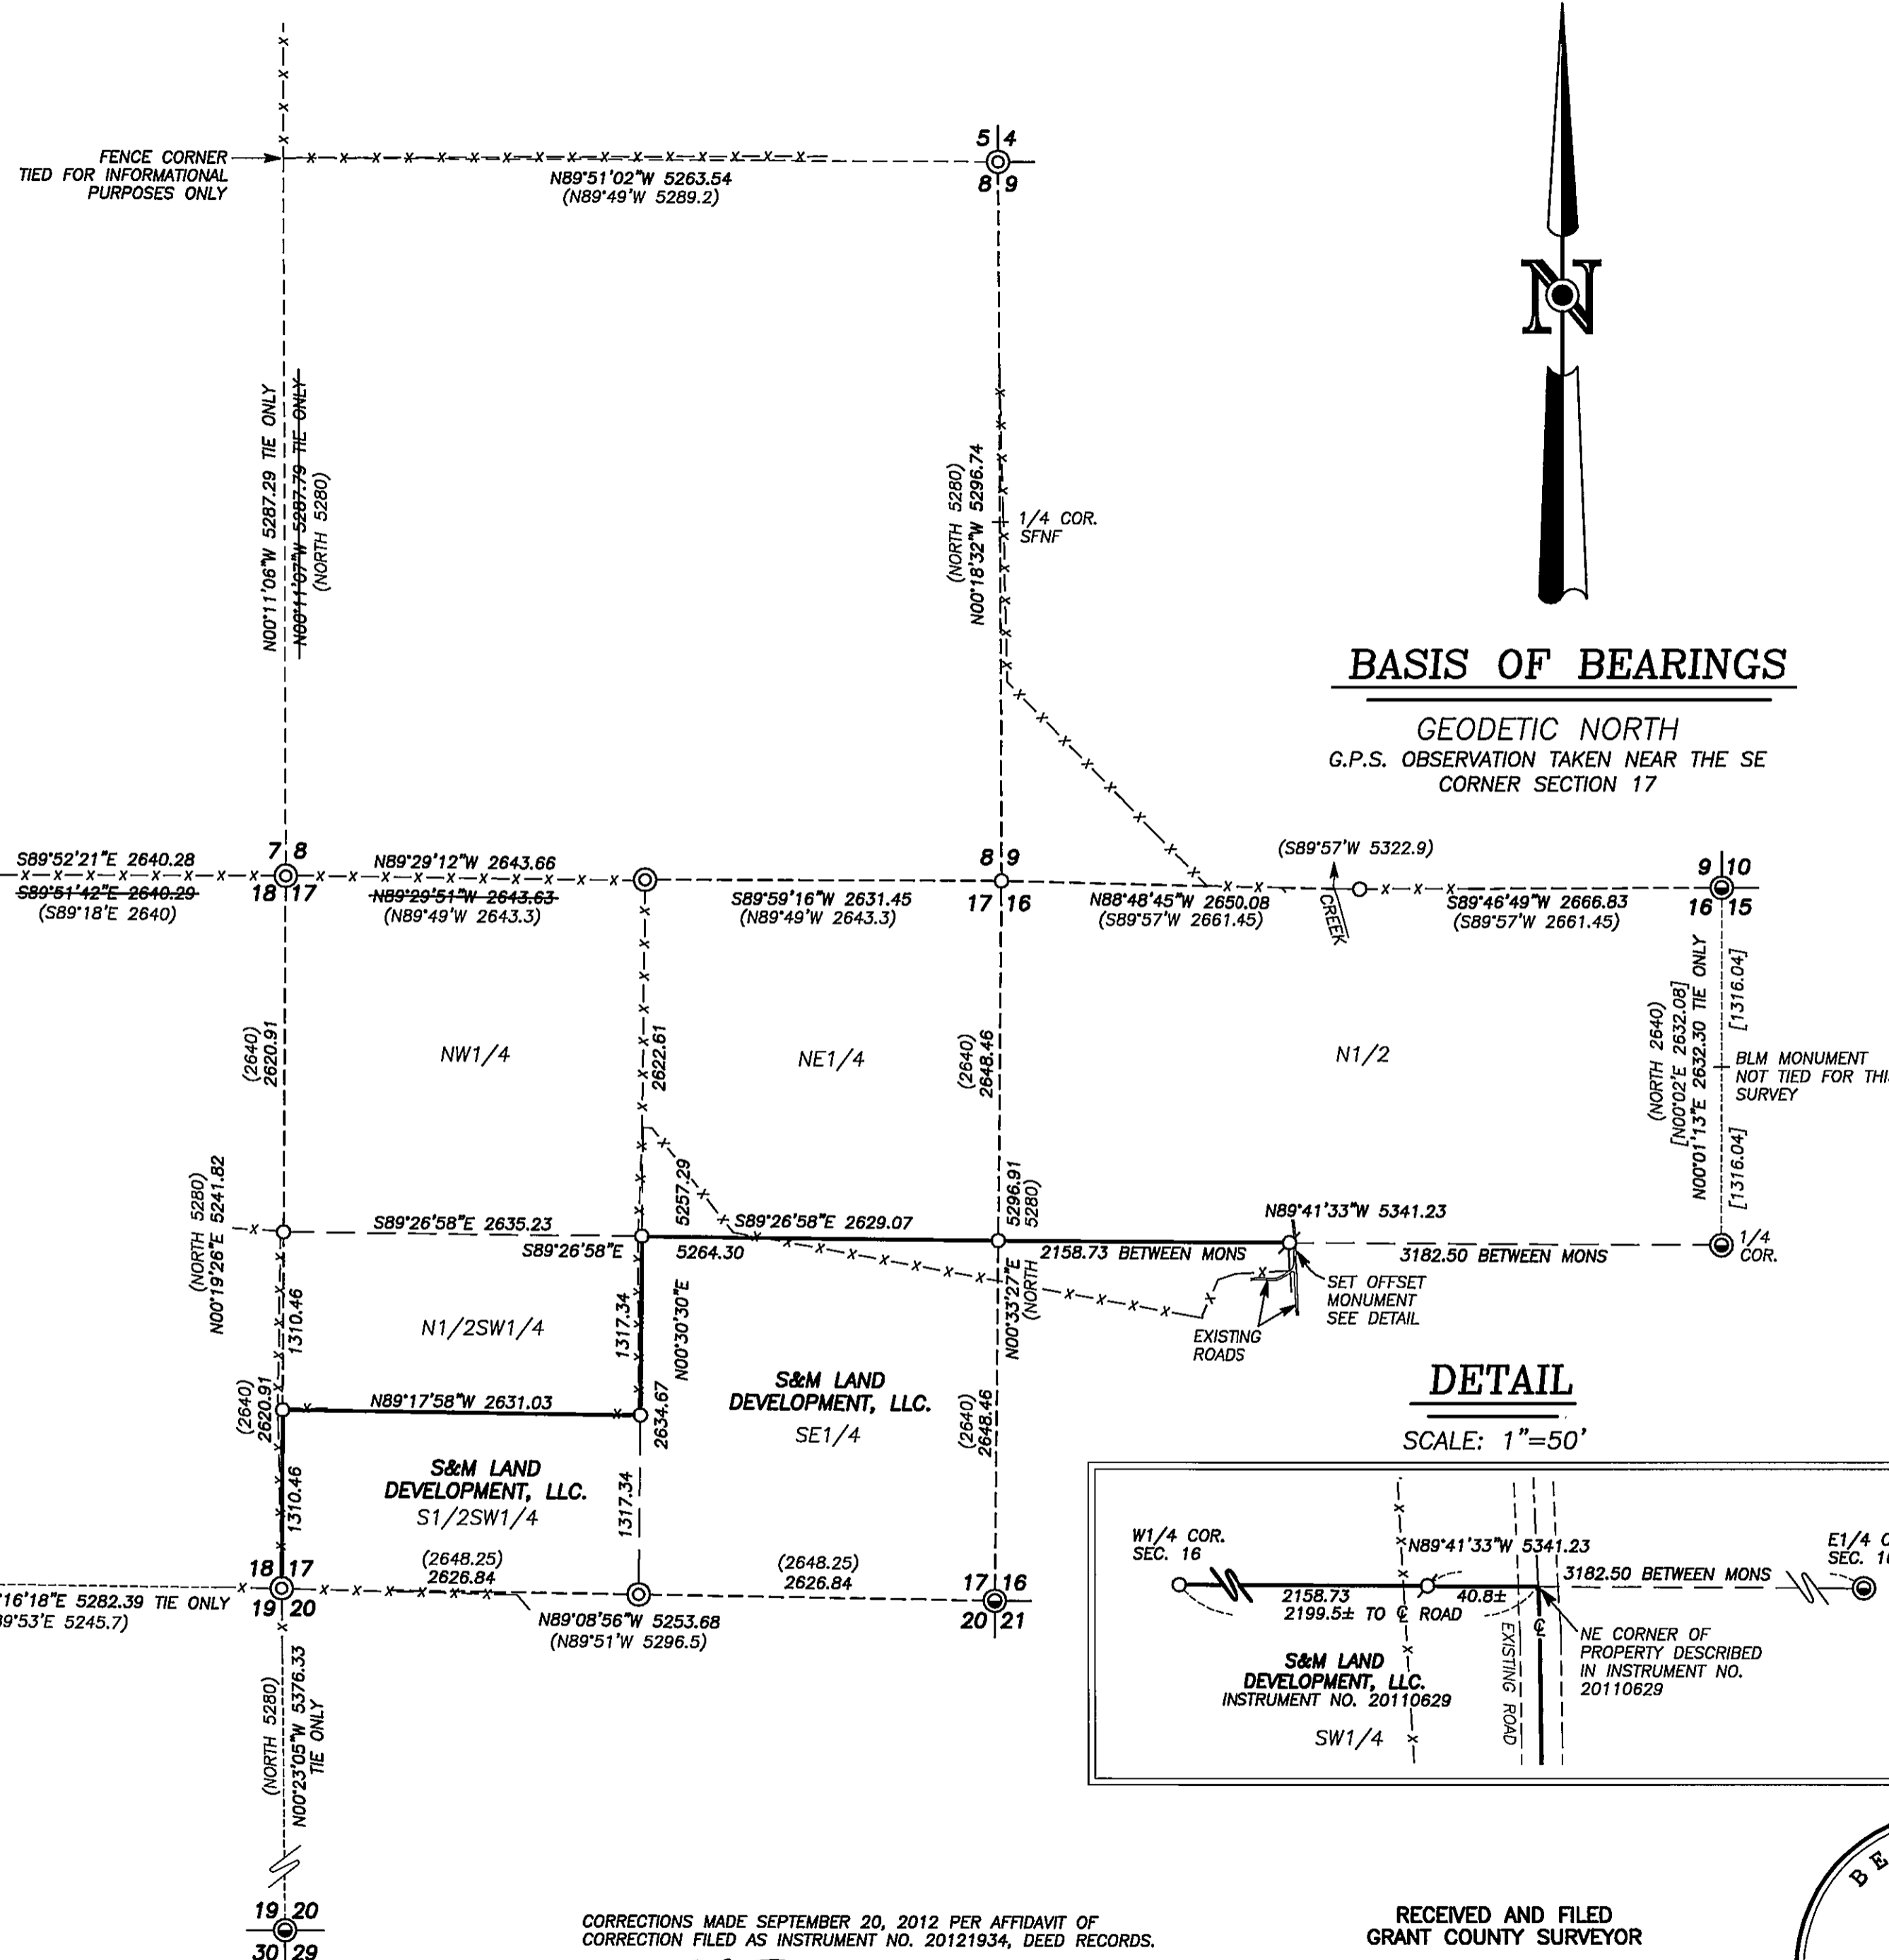
BASIS OF BEARINGS
 GEODETIC NORTH
 G.P.S. OBSERVATION TAKEN NEAR THE SE CORNER SECTION 17

This survey was performed at the request of Mike Sanders, representing S&M Land Development, LLC. The purpose of this survey was to mark the north line of the property described in Deed Instrument No. 20110629, records of Grant County, Oregon. To locate said north line, a dependent resurvey and subdivision of Section 17 was necessary.

We did not find the original corner stone. I utilized the existing east-west fence for northings, and a proportionate easting position, measuring between the found monument at the North ¼ Corner Section 18 and the established monument at the North ¼ Corner Section 17.

We did not find the original corner stone. We found an ancient fence intersection with fences extending North, East, South and West. We also found a mound of stone approximately 64 feet South of the fence intersection in the fence line. We examined every stone in the mound, but did not find the original marked stone. The mound was comprised of about 5 stones that were all substantially smaller than the one called for in the notes. I don't believe this mound is original, but is rather the remains of an old rock jack. I determined the ancient fence intersection to be the best available evidence of the section corner.

I found an unmarked stone, 14"X10"X3" set upright, 3 inches in the ground in a mound of stone comprised of eight other stones. I accept the stone and mound for the position of the section corner.

We did not find the original corner stone. Bamford Robb's field notes call for a brook 2.83 chains (186.7 feet) West of the ¼ corner. I tied this brook in the field, which relates very well when compared to its record position. The brook was contained within an incised channel. I utilized a long established east-west fence line for northings, and a proportionate easting position, measuring between the found B.L.M. monument at the Northeast Corner Section 16, and the center of the brook called for in the field notes.
