CERTIFIED RECORD OF LAND CORNER MONUMENTATION

Index File No. A-7

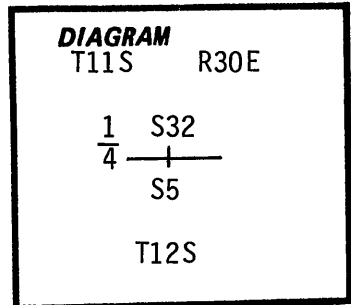
At a point established by single proportioning between the original corner evidence found at the S.W. Corner of S31, T11S R30E and the original corner evidence found at the S.E. corner of S33, T11S, R30E and calculating for the curvature of the earth as per the BLM Manual of Surveying instructions 1973 paragraph 5-31, set 2 1/2"x30" aluminum pipe with 3 1/4" cap stamped:  
Set pipe 24" in ground with mound of stone to cap.

T11S R30E  
S32  
1/4 S5  
T12S  
1981  
OR PLS 1294

Bearing trees:

A Grand Fir 11" dia. bears N57°E, 37.0 ft. scribed 1/4 S32 BT.

A Grand Fir 10" dia. bears S54°E, 24.0 ft. scribed 1/4 S5 BT.

Attached 54-3 and 54-4 signs to both BT's, and brass washer stamped LS 1294 to foot blaze of both BT's. Painted blazes and 6" band around both BT's red. Attached 54-4 sign to metal post 6 feet East of corner.
