# CORNER RESTORATION

**CORNER:** N1/4 Cor. Sec. 35 Twp. 12 S. Range 33 E., W.M.

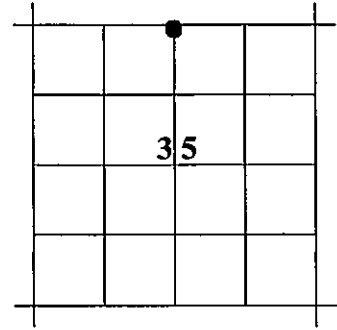
**AT THE CORNER POINT:** I set a 5/8"x30" iron pin, with attached 2" aluminum cap. Pin is driven 30" in the ground. I did not build a mound of stone as the monument is in a field that is driven across frequently. I placed a 5' fiberglass marker next to the monument. Cap is marked as shown hereon.
