CORNER RESTORATION

CORNER: N1/16 COR. SEC. 24, TWP. 13 S., RANGE 26 E., W.M.

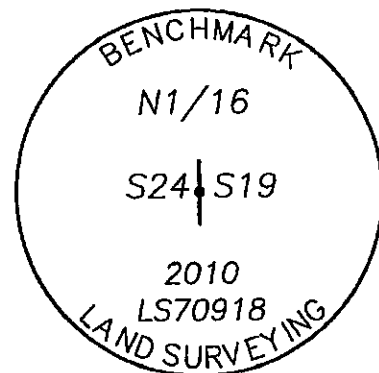
AT THE CORNER POINT: Set a 5/8"x10" iron pin with attached 2" aluminum cap, 8" into bedrock. Built a 1 foot mound of stone. Cap is marked as shown below.
