# CORNER RESTORATION

**CORNER:** C1/4 Cor. Sec. 11, Twp. 14 S., Range 30 E., W.M.

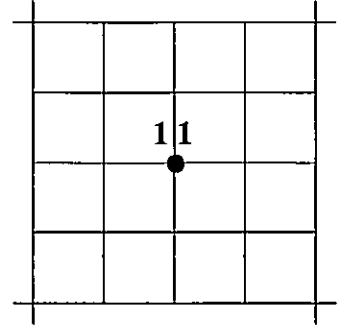
At the corner point, I set a 5/8"x15" iron pin 15" in the ground, driven to bedrock, with attached 2" aluminum cap marked as shown below. I built a 2 foot mound of stone around the monument and placed a 4 ft. steel fence post alongside the mound of stone.
