CORNER RESTORATION

CORNER: Section corner common to Sections 14, 15, 22 and 23  
Township 17 South, Range 27 East,  
Willamette Meridian

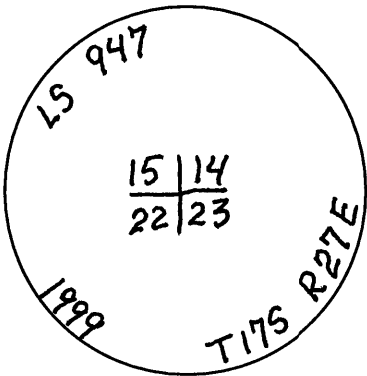
At the corner point, I set a 1” x 24” galvanized iron pipe, with a Brass Cap stamped as shown, 36” in the ground, in a field, 1 foot below surface.

From which:  
Power pole: North 87°22’ West, 162.46 feet  
Power pole: South 85°57’ West, 342.46 feet  
5/8” iron rod with plastic cap (PI): North 64°45’03” West, 769.69 feet  
5/8” iron rod with plastic cap (PI): North 22°46’28” East, 646.75 feet  
compass with 20° East variation, and measured to the center of the power poles.
