RECORD OF LAND CORNER MONUMENTATION

SOUTHWEST CORNER SECTION 2, T. 7 S., R. 28 E., W.M.

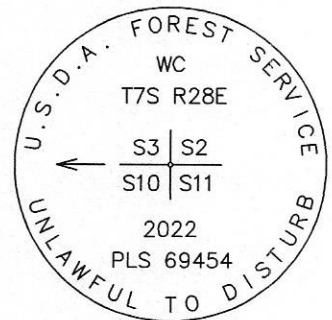
CORNER MONUMENT MARKED:

The corner point is occupied by a wooden gate post, where it is impracticable to set a monument. Therefore, I establish a witness corner on the south line of Section 2. At a point which is S.89°02'35"E., 10.00 feet from the true corner position, I set a 5/8"x24" iron pin 12" into a drill hole in bedrock, and attached a 3 1/4" USFS brass cap, marked as shown below. Raised a 3 ft. diameter mound of stone around the monument to top of cap.
