CERTIFIED RECORD OF LAND CORNER MONUMENTATION

V-9

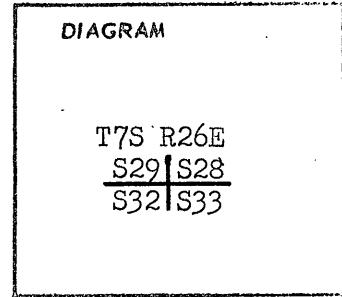
Stone 24X13X6 in Stone Mound

Badly fragmented stone 19 X 13 X 6 in stone mound.

Set 32" X 2" flanged iron pipe with brass cap marked:

T7S R26E
 S29 | S28
 S32 | S33
 1979
 PLS 346

Ponderosa Pine, 23" Dia., BRS. N78°E, 20.2 Ft. Distance.

Marked: T7S R26E S28 BT

Ponderosa Pine, 14" Dia., BRS. S 4¼°E, 23.4 Ft. Distance.

Marked: T7S R26E S33 BT

Douglas Fir, 7" Dia., BRS. S79½°W, 12.1 Ft. Distance.

Marked: T7S R26E S32 BT

White Fir, 13" Dia., BRS. N45°W, 16.2 Ft. Distance.

Marked: T7S R26E S29 BT

6' Iron Fence Post with "Attention" sign within 5' of Corner.

All BTs have BT tag, painted red stripe and brass washer stamped: PLS 346; nailed to lower blaze.

Buried original stone alongside iron pipe.
