RECORD OF SURVEY

SECTIONS 19, 25, 26, 28, 29, 33, 34 & 35,
TOWNSHIP 8 SOUTH RANGE 26 EAST
WILLAMETTE MERIDIAN, GRANT COUNTY, OREGON

SURVEY FOR THE UMATILLA NATIONAL FOREST
KAHLER DRY FOREST RESTORATION PROJECT
LOCATED IN SECTIONS
19, 25, 26, 28, 29, 33, 34 & 35,
TOWNSHIP 8 SOUTH, RANGE 26 EAST
WILLAMETTE MERIDIAN, GRANT COUNTY, OREGON

SHEET 5 of 10

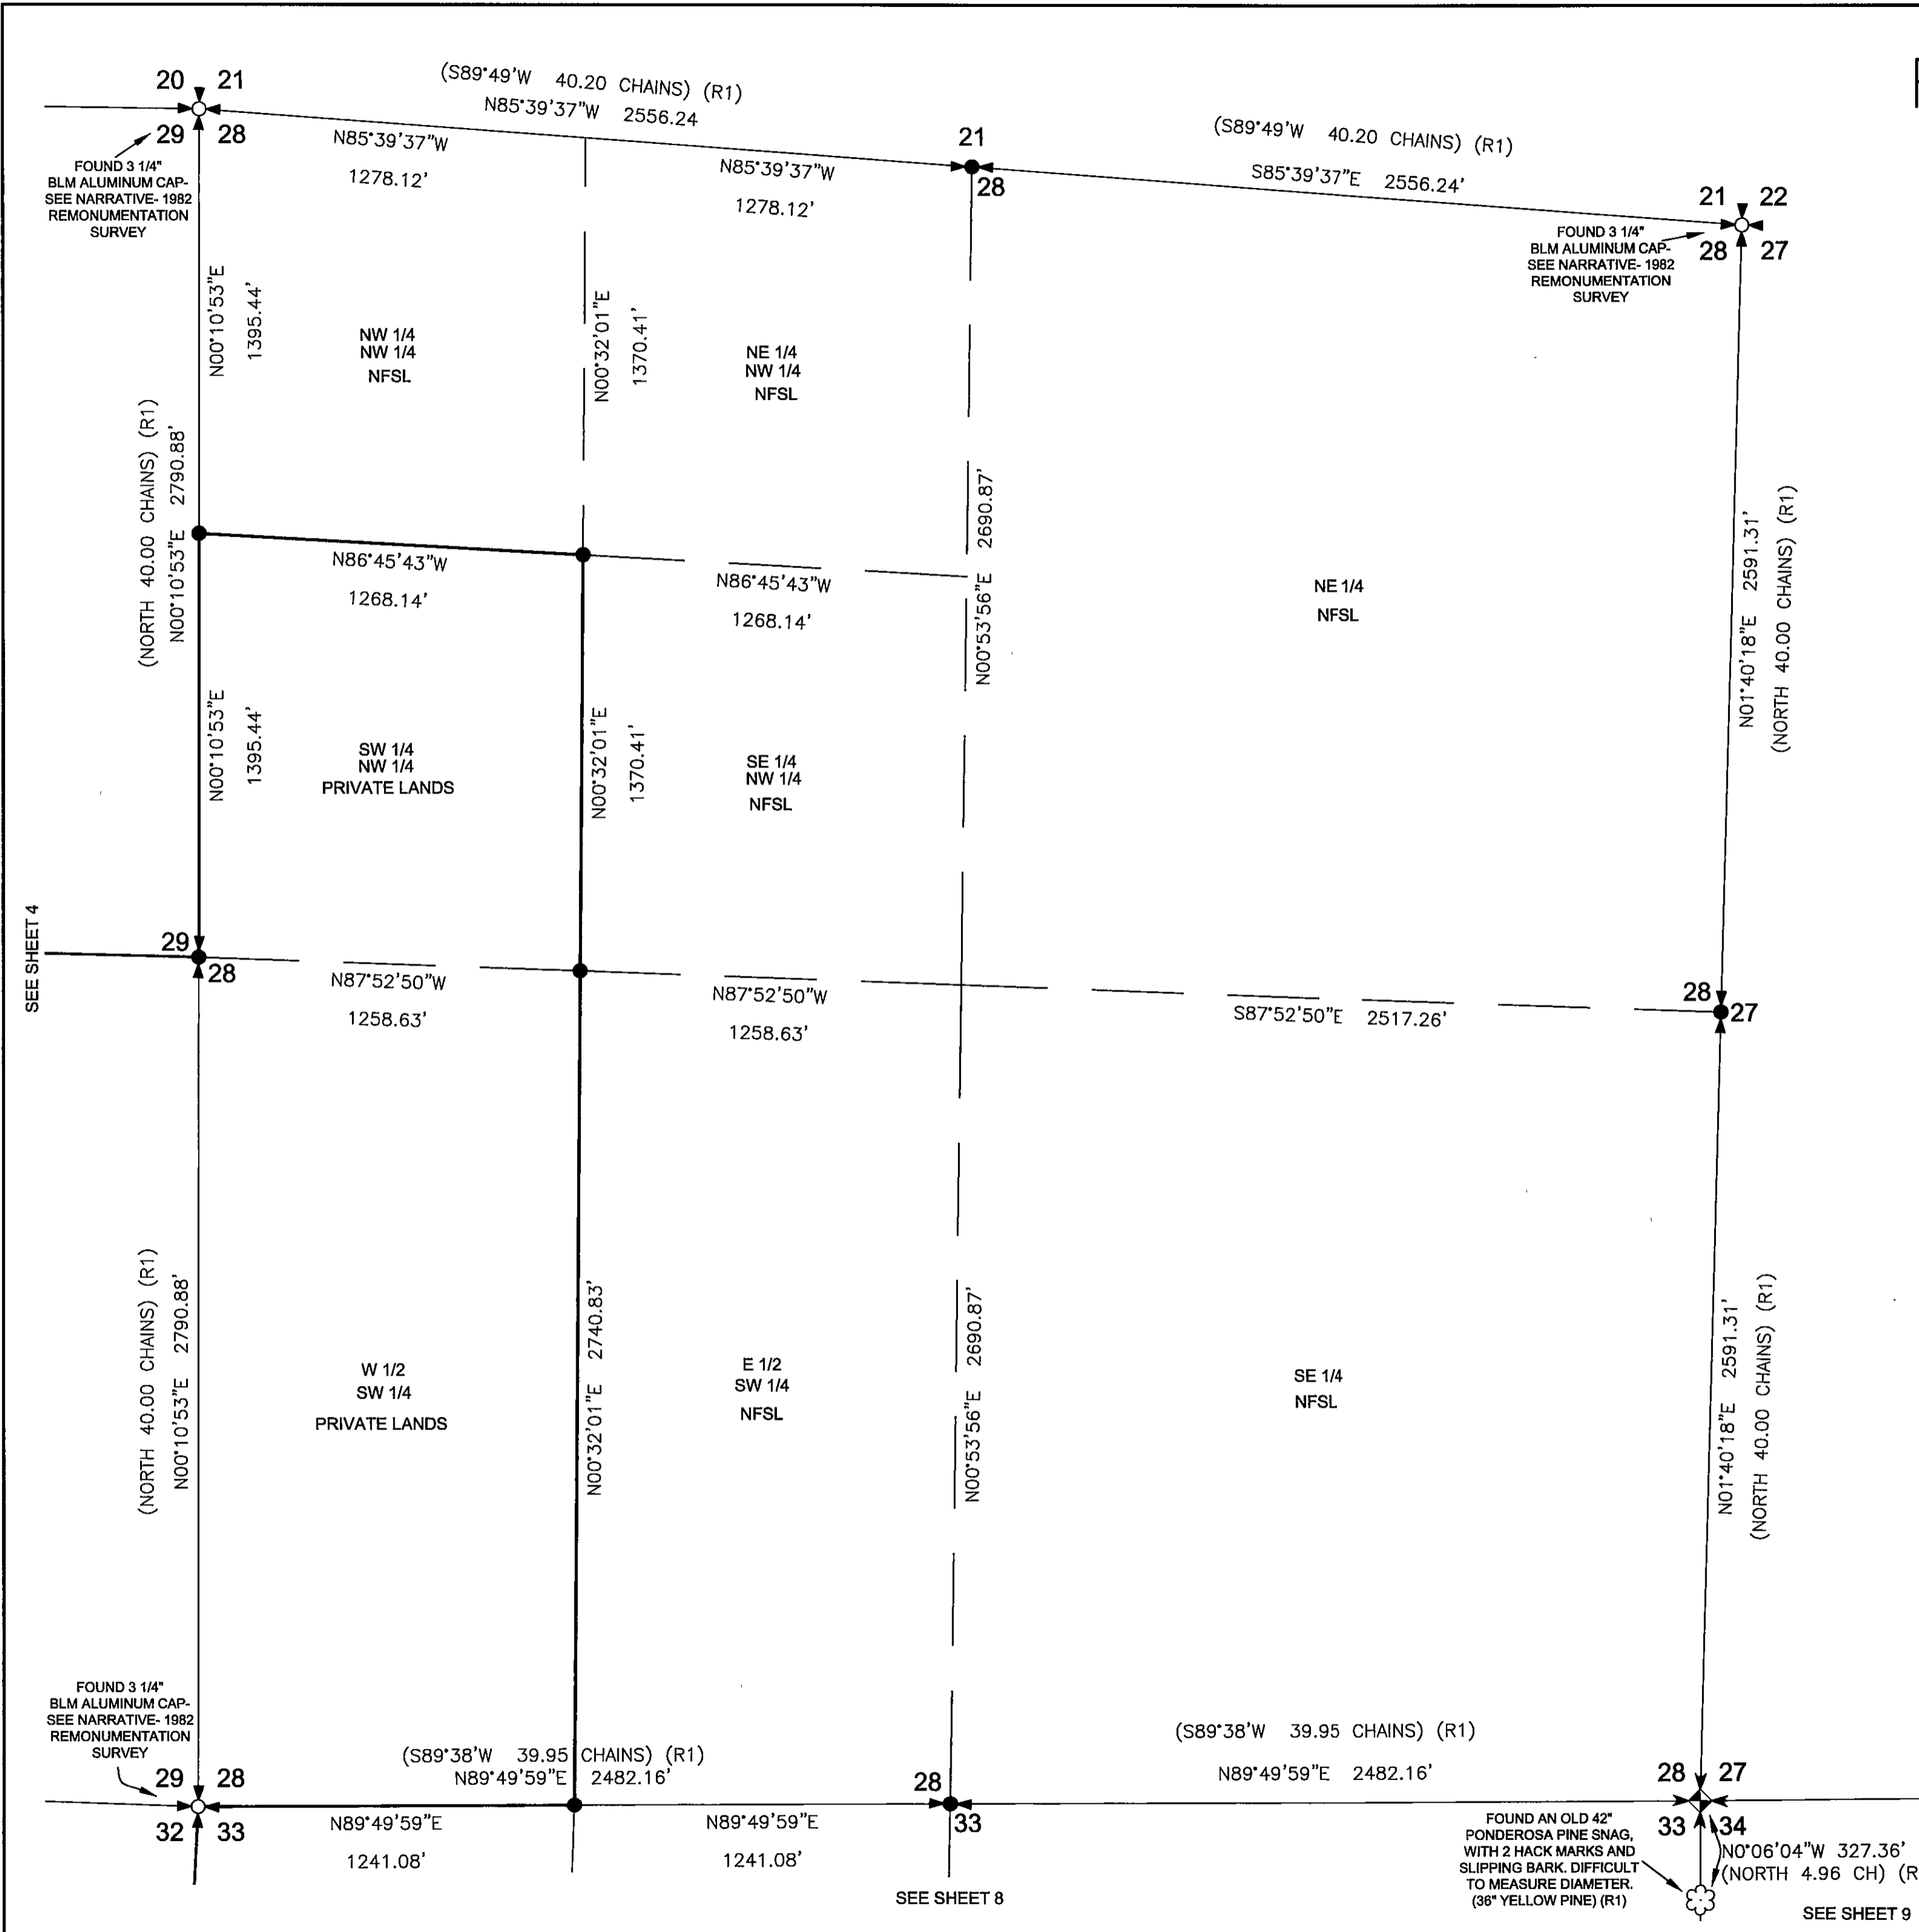
FOUND 3 1/4" BLM ALUMINUM CAP. SEE NARRATIVE- 1982 REMONUMENTATION SURVEY

FOUND AN OLD 42" PONDEROSA PINE SNAG, WITH 2 HACK MARKS AND SLIPPING BARK. DIFFICULT TO MEASURE DIAMETER. (36" YELLOW PINE) (R1)
