CORNER RESTORATION

Sec. 1

CORNER SW 1/16 Cor. TWP T14S RANGE R32E

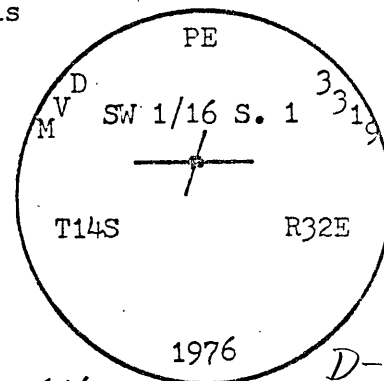
MONUMENT MARKED

At the corner point: Set a monument, mounted on a 2"x22" iron pipe, set 12" in the ground with rocks piled up to 4" below the brass cap. (The monument is set only 12" in the ground because I hit a layer of rock just under the ground surface.) The brass cap is marked as shown.

A Juniper 8" diam., bears $N44^{\circ}E$ 29.8 ft., mkd. SW1/16 S1 BT.
A pine 10" diam., bears $N89^{\circ}W$ 13.9 ft., mkd. SW1/16 S1 BT.
These trees were scribed and tagged by the G.C.S.
